Report No. VTRC 05-R31	Report Date June 2005	No. Pages 36	Type Report: Final Period Covered: August 2003-April 1, 2005	Project No.: 73849 Contract No.
Title: Use of Soil Stabilizers on Highway Shoulders				Key Words: shoulders, soil stabilizers, soil additives, aggregates, shoulder reclaimer, pavement edge drop-off
Author: Daniel S. Roosevelt, P.E.				
Performing Organization Name and Address: Virginia Transportation Research Council 530 Edgemont Road Charlottesville, VA 22903				
Sponsoring Agencies' Name and Address Virginia Department of Transportation 1401 E. Broad Street Richmond, VA 23219				
Supplementary Notes				
<p>Abstract</p> <p>This study evaluated soil additives as stabilizers for aggregate and topsoil shoulders. Its purpose was to determine (1) the effect soil stabilizers have on the strength and stability of soil shoulders, and (2) the costs and benefits of using stabilizers versus paving the shoulder or maintaining the shoulder as originally composed. The study used test and control sections to assess two stabilization products, Soiltac and Centrophase AD, used with one type of shoulder material (crusher run stone). The experimental sections were installed at one l

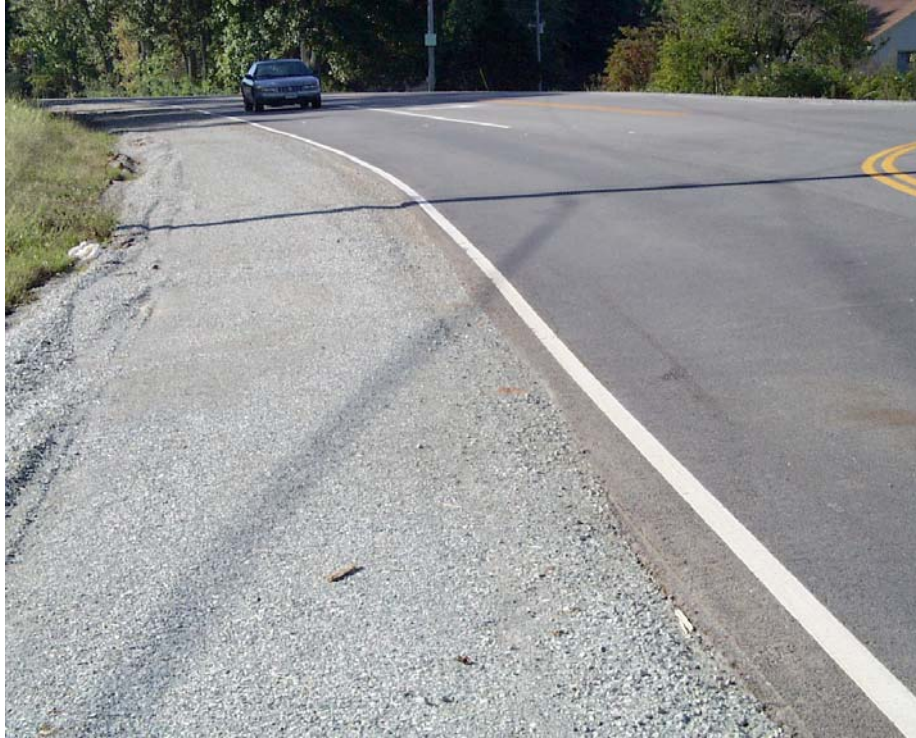
Findings from the visual inspections varied little over the life of the study. The findings of the initial inspection on September 14, 2004, are provided in Table 3. The September 21, 2004, inspection indicated a low unpaved shoulder drop-off over <25% of the Soiltac section length. Figure 3 indicates the magnitude of the condition. All low areas occurred on the curved section of roadway near the Route 651 intersection. The October 6, 2004, inspection indicated no further change in the test sections but low areas over <25% of the control section. Figure 4 indicates the magnitude of the condition.

Figure 3. Low Shoulders along Soiltac Test Section, 9/21/2004

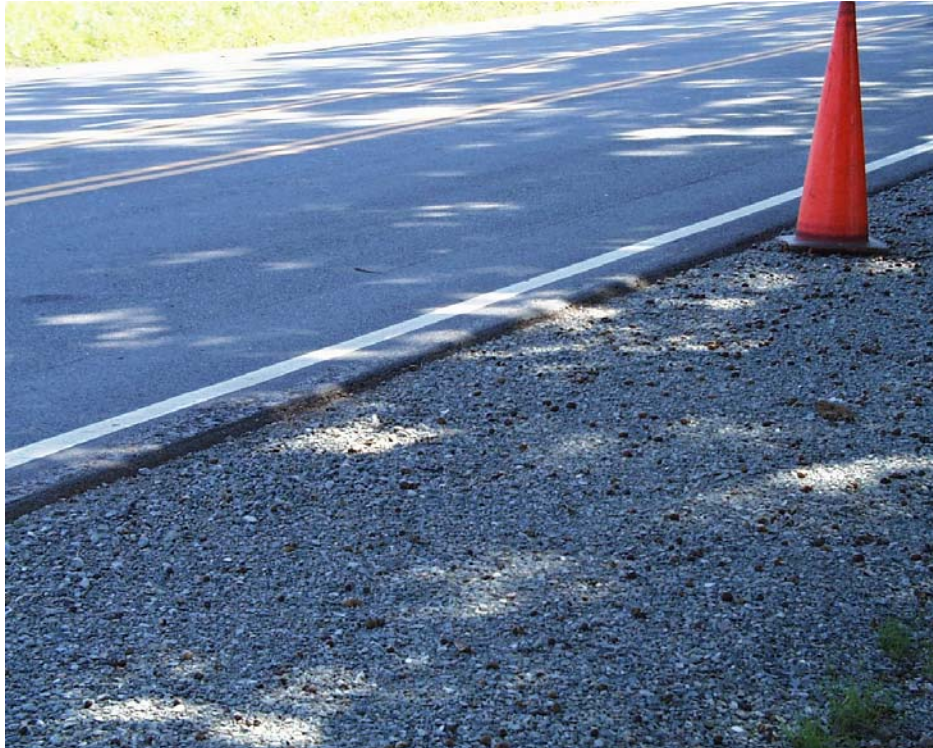
Figure 4. Low Shoulders Along Control Section, 10/6/2004

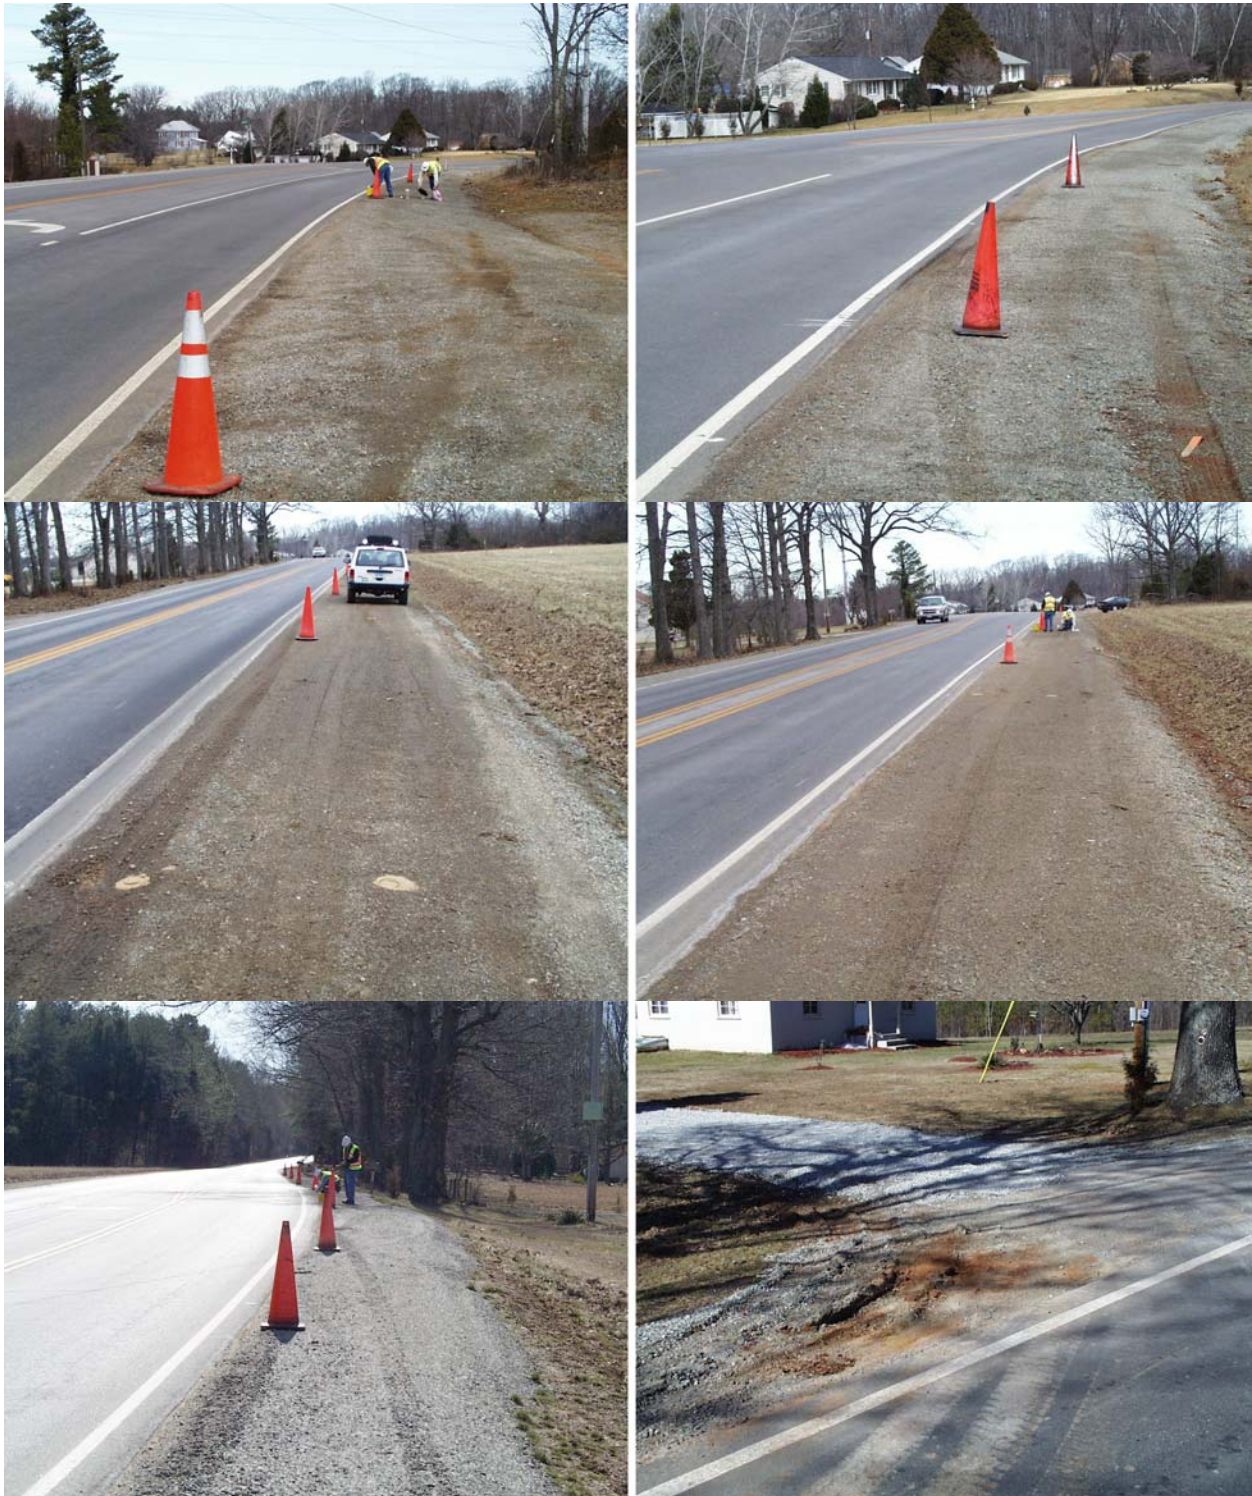
The rating form for February 8, 2005, indicated 25% to 50% of the Soiltac section had low shoulders and rutting over 50% of its length. The Centrophase AD section had rutting over 50% of its length. The control section had considerable damage at a private entrance but otherwise had not deteriorated further. Figure 5 shows the condition of the three sections. Notes from the February 8 visual inspection indicate the Centrophase AD and Soiltac sections were soft. Surface material was wet and rutted under the tire pressure of a sport utility vehicle. The control section was relatively dry and hard when compared to the test sections but showed signs of rutting.

Figure 5. Test and Control Sections, 2/8/2005. Top, Soiltac; middle, Centrophase AD; bottom, control.

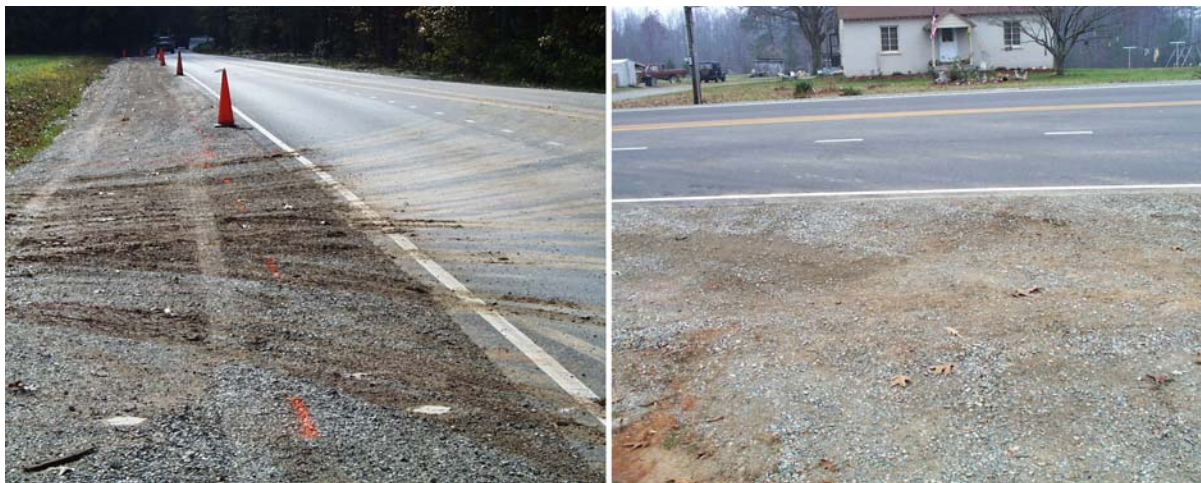
An unpaved field entrance exists across the **Soiltac** section. From early October to mid-November, the entrance was used intermittently by logging trucks. Data points 1 and 2 in the **Soiltac** section were in the path of the logging traffic. As with the private entrance in the control section, the stiffness data for all the **Soiltac** locations were compared with the mean for each data collection date. Only the stiffness value for data point 1 on October 26 exceeded 2 standard deviations from the mean. The data for that date were tightly distributed around the mean, and the standard deviation was only 22% of the value of the mean. Views of the entrance on October 26 and November 22 are shown in Figure 7. The log trucks did track some mud onto the

Figure 7. Conditions at Field Entrance on Two Dates. *Left, October 26; right, November 22.*

shoulder on that date, but no distress as defined by the RCA manual was noted on either date. Based on these facts, all stiffness data collected for the **Soiltac** section were retained in the analysis that follows.

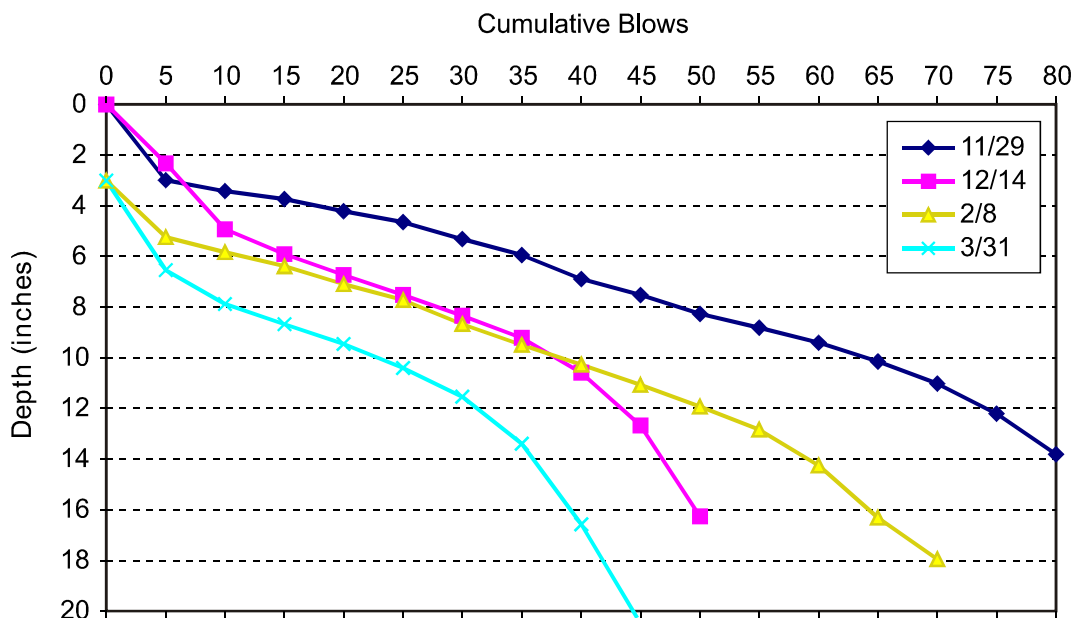
Although through traffic did not have a strong impact on the test and control sections, the condition of the shoulder at the private entrance gave some indication of the damage traffic running on the shoulder might do. DCP penetration data collected at C-6 over the life of the project are shown in Figure 8. The steeper the slope on the line connecting adjacent data points, the less resistant the material is to penetration. Although the shoulder area adjacent to C-6 showed some distress on the first two dates graphed, the low shoulder condition at this location did not become evident until the inspection of February 8. To account for the effect of the lost shoulder material and allow a better comparison of the data for the four dates, the zero point for the DCP penetration data was set 3 in lower for the February 8 and March 31 data.

The data support this scenario. On November 29, the capacity of the shoulder material to carry the traffic loads was lower in the first 3-in-depth of material than it was below that point. By December 14, traffic action caused the depth of reduced capacity (loose) material to reach 5 in. Sometime between December 14 and February 8, something caused the loose material to shift until the depth of the loose material returned to a depth of 2 in or less. At some point between December 14 and March 31, the cycle began again and the effect of traffic action on the shoulder caused the depth of loose material to increase. Without maintenance, when the loose material reaches a depth of 5 in or more, the deformation will occur again and increase the size and depth of the hole.

Figure 8. DCP Penetration Readings for Sample C-6 Adjusted for Shoulder Elevation
