Report No. VTRC 05-R31	Report Date June 2005	No. Pages 36	Type Report: Final Period Covered: August 2003-April 1, 2005	Project No.: 73849 Contract No.
Title: Use of Soil Stabilizers on Highway Shoulders				Key Words: shoulders, soil stabilizers, soil additives, aggregates, shoulder reclaimer, pavement edge drop-off
Author: Daniel S. Roosevelt, P.E.				
Performing Organization Name and Address: Virginia Transportation Research Council 530 Edgemont Road Charlottesville, VA 22903				
Sponsoring Agencies' Name and Address Virginia Department of Transportation 1401 E. Broad Street Richmond, VA 23219				
Supplementary Notes				
<p>Abstract</p> <p>This study evaluated soil additives as stabilizers for aggregate and topsoil shoulders. Its purpose was to determine (1) the effect soil stabilizers have on the strength and stability of soil shoulders, and (2) the costs and benefits of using stabilizers versus paving the shoulder or maintaining the shoulder as originally composed. The study used test and control sections to assess two stabilization products, Soiltac and Centrophase AD, used with one type of shoulder material (crusher run stone). The experimental sections were installed at one l

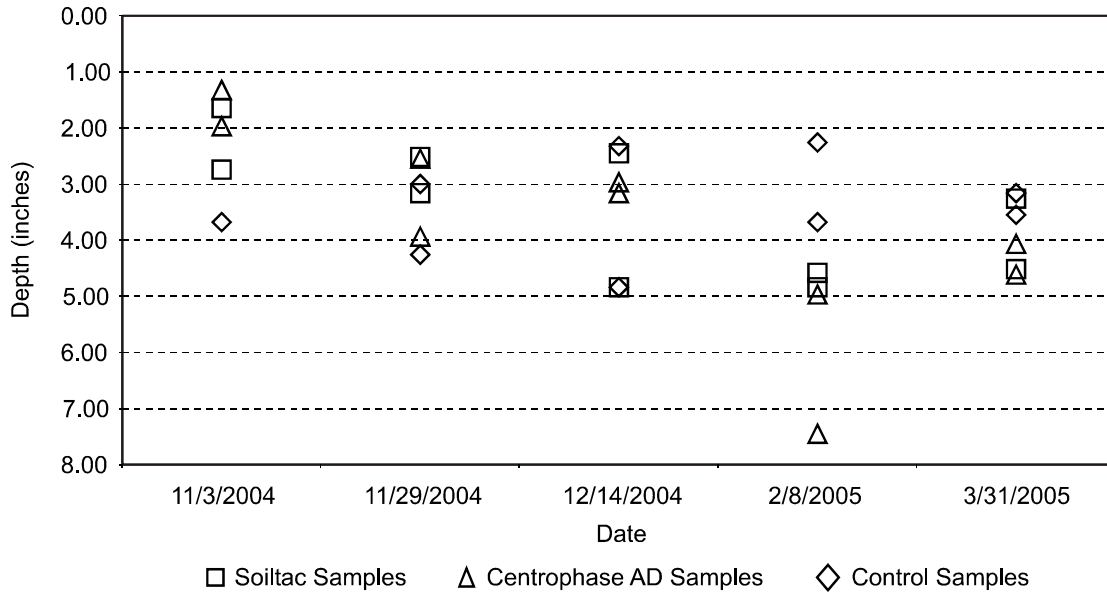
The DCP penetration data are shown in Appendix D. For convenient comparison with GeoGauge™ and visual inspection data, the DCP initial penetration data for each sample site are shown in Figure 1. To place these data in perspective, a CBR 10 material under controlled density and moisture conditions should produce DCP readings of approximately 0.8 in for every five blows.

Figure 1. Initial DCP Penetration (at five blows), by Date

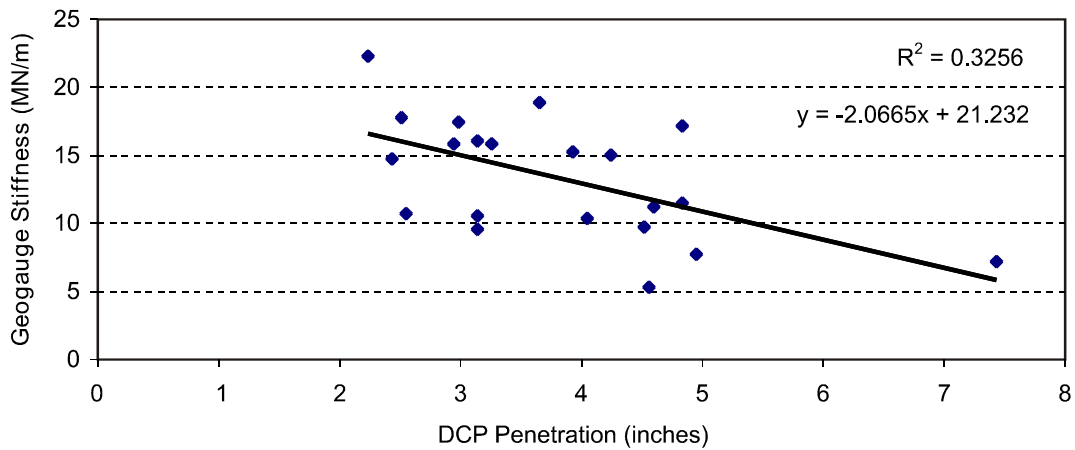
A scatter plot comparison of the DCP and GeoGauge™ data collected on similar dates and locations is shown in Figure 2. The R² value indicates there is not a good correlation between the two sets of data.

Figure 2. Scatter Plot of GeoGauge Stiffness Readings and DCP Readings for Corresponding Location and Date

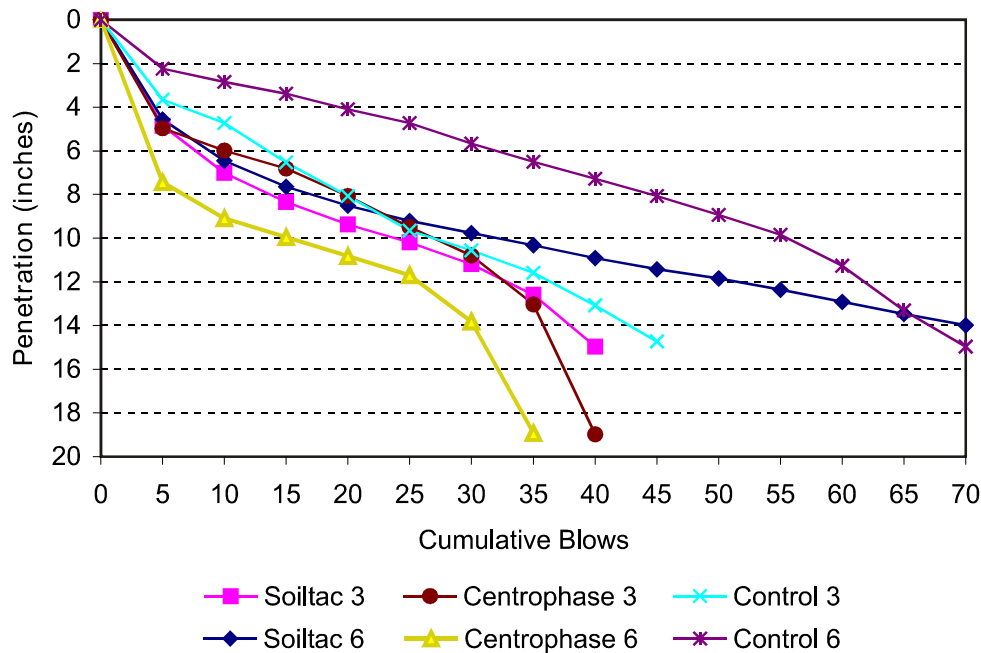
DCP penetration data for February 8 are shown in Figure 6. The data support the Geogauge and visual inspection data and indicate the lack of support extended well into the ground. The data showed that the full depth of the treated material in both test sections had lost strength. One of the Centrophase AD samples indicated the loss of strength extended well below the treated material.

Figure 6. DCP Penetration Data, 2/8/2005
