**THE VALLEY OF THE KINGS, LUXOR, EGYPT
SITE MANAGEMENT MASTERPLAN**

**Dr Kent R. Weeks
Nigel J. Hetherington
Edited by Lucy T. Jones**

**A PUBLICATION OF
THE THEBAN MAPPING PROJECT
V
CAIRO 2006**

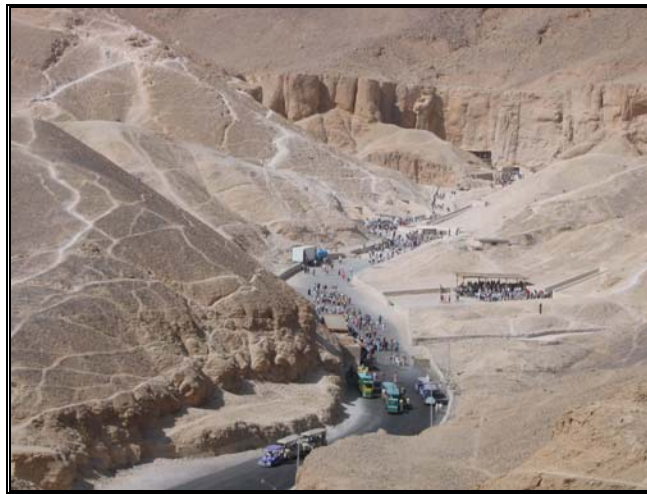
Figure 74: Existing Road Surface

- B.** The road between the Visitors Center and KV is currently paved with asphalt, and that paving extends into the Valley, nearly to the entrance of KV 6. We suggest that this asphalt be removed and the road between the Center and the Valley be left as a natural surface. Beyond the Visitors Center, the idea is to have KV look as much as possible as it looked a century ago, with minimal modern intrusions. To eliminate problems with blowing dust, wear, and flood damage, the roadway, and also the footpaths throughout KV, should be sprayed with a liquid copolymer soil stabilizer such as Soiltac (Appendix V). We tested Soiltac on the dirt road running north to south immediately west of Carter House and have found that, 10 months later, in spite of regular use by lorries and tractors, the track remains dust-free and undamaged. Soiltac should also be used on the footpaths in KV itself, both to reduce dust and to create a waterproof surface that, by careful grading, can be used to safely deflect flood water from tomb entrances and direct it out of KV, around the Visitors Center and bus park, and into the desert.

- b) Remove asphalt from entrance to KV to Visitors Center in a series of 2-3 strips (so as not to interfere with continuing tourist traffic) and lay down Soiltac or equivalent
